Study of the performance of adobe brick coated for sustainable construction in the Algerian Sahara

Abstract. This article describes a study conducted to determine the ideal both traditional and stabilized composition of adobe as a building material, and to further refine an appropriate choice of coating composition for extended durability of these constructions in adobe: choose the suitable coating that fits the most with its substrate. The constructions in Z'gueg El Hadjadj [Laghouat town, Algeria] consist of adobe walls but also plaster that serves as a coating for these brick walls. The degradation phenomena of the building are considered in the adobe-coated couple, and consequently in the suitability of their compositions. The compatibility of plasters with adobes remains a major factor in the restoration and conservation of earthen constructions. This paper examines the results of the experimental characterization of the behavior of coated bricks, which consists of studying in the laboratory the water resistance: the drying-wetting test and the capillary rise test, as well as the complementary accelerated aging test: the abrasion test. These tests will be supplemented by anot

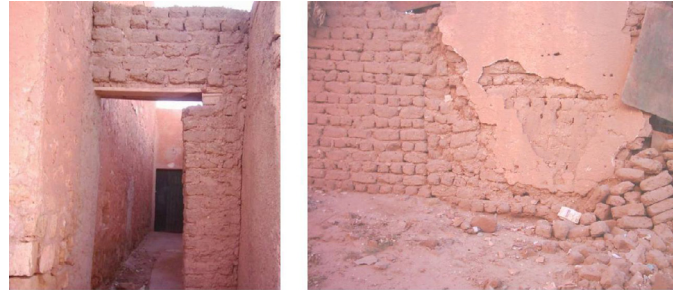
Fig. 1. A typical example of decrepitude of an adobe wall. Source: 3rd year students of architecture department (2005–2006).

The construction of Z'gueg El Hadhadj¹ district has obeyed many architectural rules. The stone foundations repose walls of adobe bricks “attub”: A mixture of earth and straw according to a procedure that consist in moulding the raw material in wooden moulds and then drying them in the sun, these adobe walls insulate from the heat and the cold. The neighborhood built from adobe, as a main material, takes its color from its homeland, that is going from ochre to brown (Fig. 1).

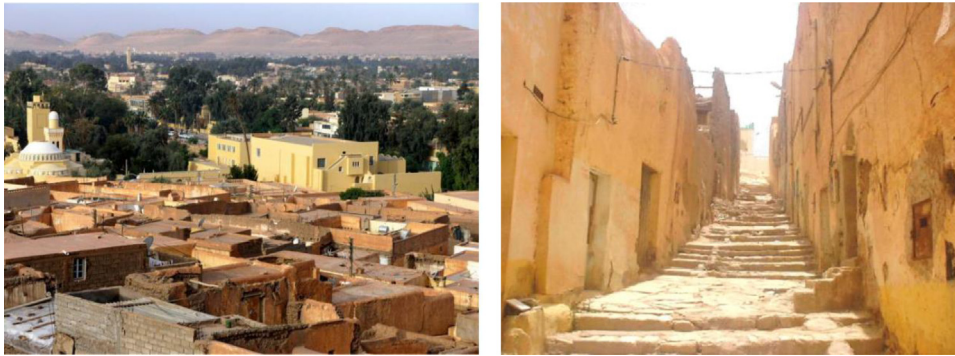
Fig. 2. Architectural qualities of the district. Source: 3rd year students of architecture department (2005–2006).

Z'gueg El Hadjadj is a district whose earthen houses represent a precious cultural heritage to Laghouat city (Fig. 2). This architectural and historical heritage hasn't been neither the object of serious global inventory campaign nor centralized protection. Many houses stayed unoccupied and are intended ruin. The first consequence of the abandonment and the ruin of this rich heritage is depreciation of the earthen material: we attribute its poor

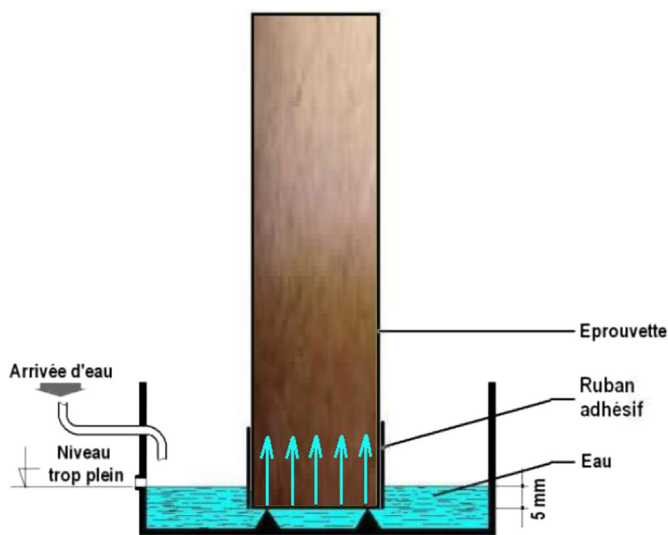
**Fig. 3.** Diagram of absorption test device.**Fig 3.** Diagramme du dispositif d'essai d'absorption.

The pre-dried samples are placed vertically in a plastic container containing water above small carriers according the schema indicated in Figure 3, so that the water does not touch the specimen that is higher than 5 mm of the bowl depth, the rest of the sample is previously waterproofed by a water proof tape on all the other surfaces. Then, we measure the increase of the mass of the sample in function of time at 5, 10, 20, 40, 60, 90, 120, 180 and 240 min.

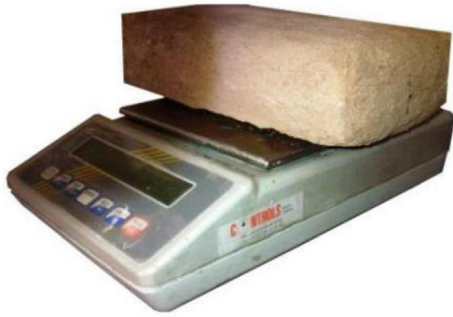
Fig. 4. Balance of accuracy 0.1 g.

A high precision scale will be used in the weighting of samples in accordance with the weighing requirements.

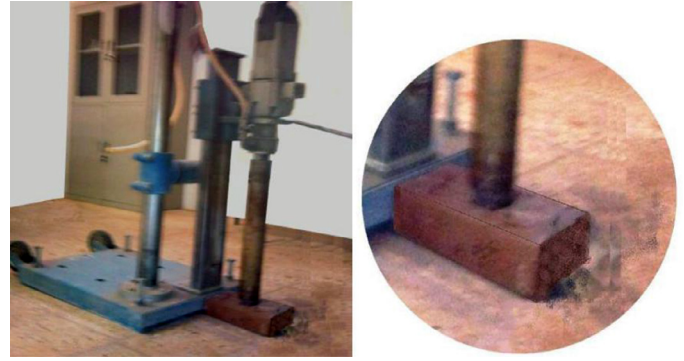
Fig. 5. Coring device.

The core drill tube must penetrate the sample across the entire surface and penetrate into the substrate within about 5 mm depth (Fig. 5). On the surface, a metal pastille having the same diameter is stuck with a fast adhesive of the brand ALTECO 3-TON QUICK EPOXY, available on the market. The adhesion test consists of applying on the ball head a normal traction effort on the pastille surface.

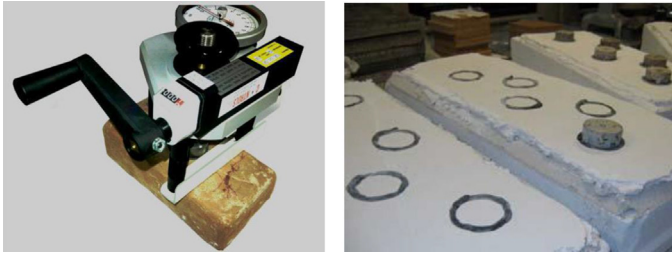
Fig. 6. Setting up sample in the test device.

Then, these samples will undergo the tests according to the specifications previously noted in the general specifications of adhesion test in Figure 6.

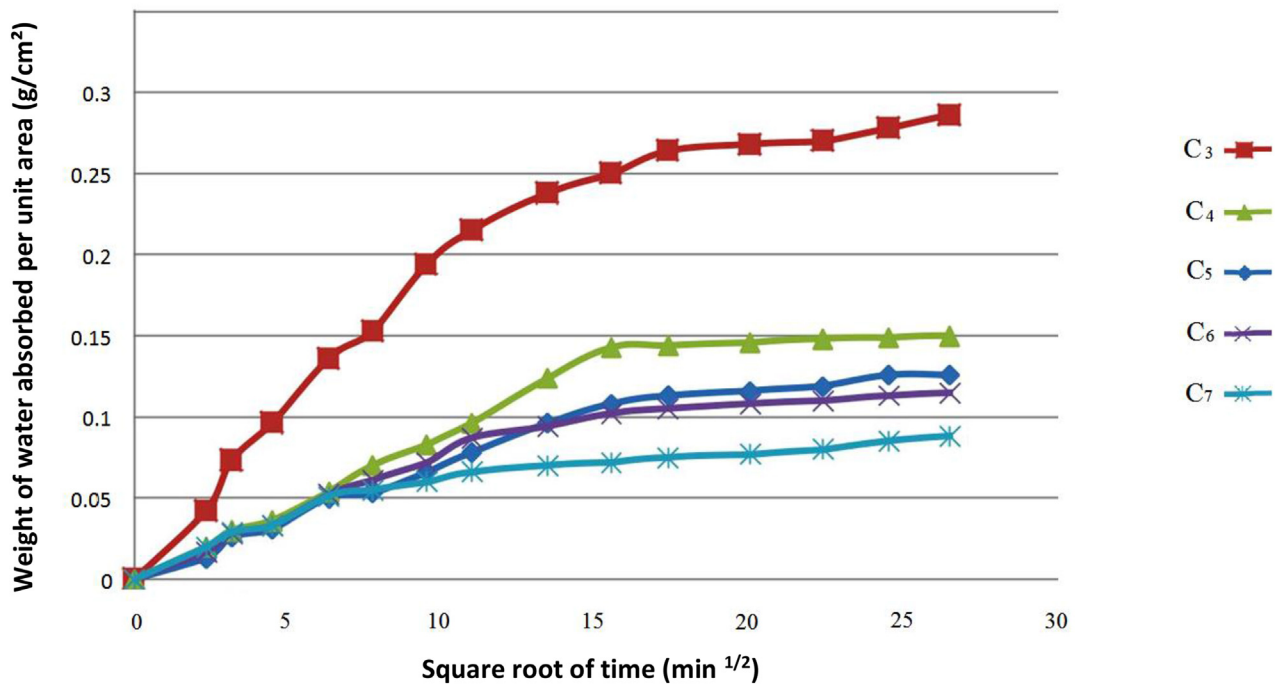
Fig. 7. Variation in the quantity of water absorbed per unit area in over time.

Figure 7 presents the evolution of the rate of absorption according to the coating dosage in cement and lime for various period of immersion. It is observed for the C₇, where the 3 layers containing cement, that the quantity of water absorption by capillarity remains the lowest. This phenomenon may be explained by the fact that cement helps to reduce the porosity of the coating. Compared with all samples, the C₃ absorbs a large amount of water. This phenomenon is opposite to that observed with the cement dosage. It can be explained by the fact that, according to P. Maurenbrecher et al., the mortar with a high lime content (2 to 3 times more lime than cement by volume) is more porous than a cement mortar.

The overall porosity of the coating being higher, the tendency to absorb water is then greater. For C₄, C₅ and C₆, their tendencies are closed to the C₇.

We note for the samples of C₄ and C₅, the tendency of an ability of capillary absorption are almost identical with a saturation time respectively equal to 400 and 600 for 2 min knowing that for two volumes of cement, the 3rd

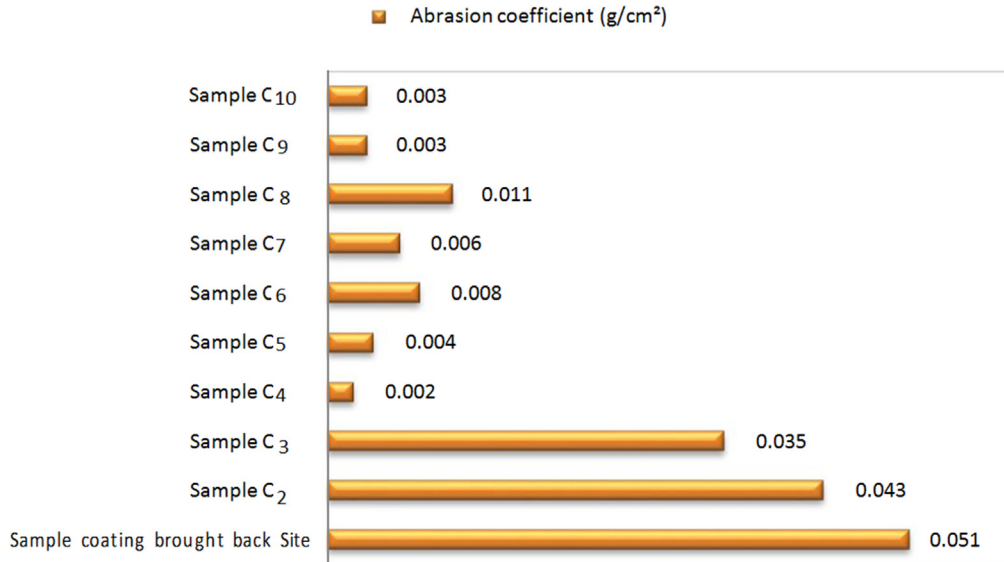
Fig. 8. Abrasion resistance of the various coatings.

The coating of C₄ whose last layer is composed of 2FS + 1.5L + 1C displays the best resistance to this abrasion test with $0.002 g/cm^2$, followed by the earth based coatings of C₉ and C₁₀ whose 3rd layers are composed of 1FS + 1/4C and 1FS + 1L + 1/2C with $0.003 g/cm^2$ each. Comparing to the coatings previously mentioned, the coatings of C₃ whose 3rd layer is composed of 2FS + L + 1/8C and C₂ whose the last layer is composed of 2FS + 1L show a very weak resistance with respectively 0.035 and $0.043 g.cm^{-2}$, for the coating brought from the site, the latter produces the lowest resistance with $0.051 g.cm^{-2}$ (Figs. 8 and 9).

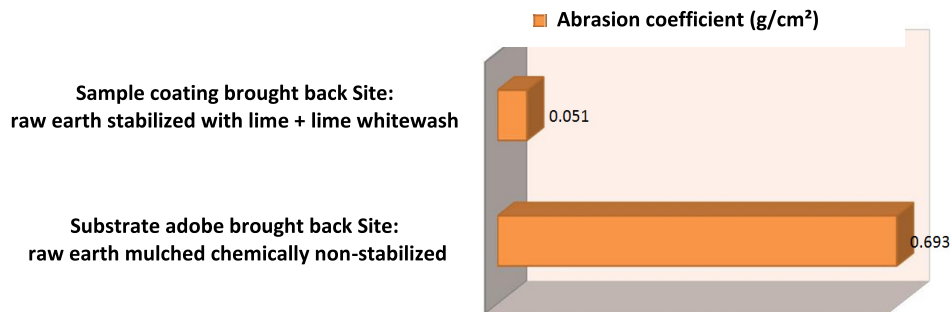
Fig. 9. Comparison of the abrasion resistance of the coating on its support.

Compared to its substrate, the sample of coating brought from the site displays an abrasion resistance of 13.6 times higher, because the tested adobe does not present any obvious chemical stabilization, except for a few strands of straw and some impurities, unlike its coating which is by different composition of whitish color with the presence of whitewash layer on the decorative layer.
